# DEVELOPMENT OF CBR DESIGN CURVES FOR AM1 LANDING MAT

MISCELLANEOUS PAPER NO. 4-599

September 1963

U. S. Army Engineer Waterways Experiment Station  
CORPS OF ENGINEERS  
Vicksburg, Mississippi

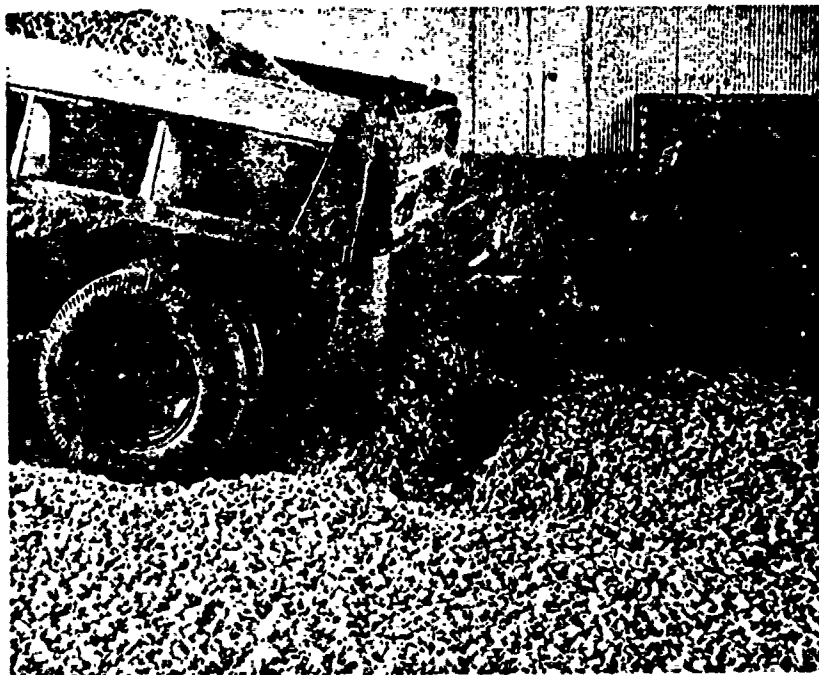
Fig. 3. End-dumping of rock in item 3'

10. Items 3 and 4. Item 3 of the test section consisted of 12 in. of uncompacted, loose rock that had been end-dumped (fig. 3) and spread by hand. Item 4 consisted of 24 in. of uncompacted sand that had been end-dumped (fig. 4) and spread with a D4 tractor. A CBR of about 3 was measured in the sand item prior to placement of the mat. A CBR of 3 for a

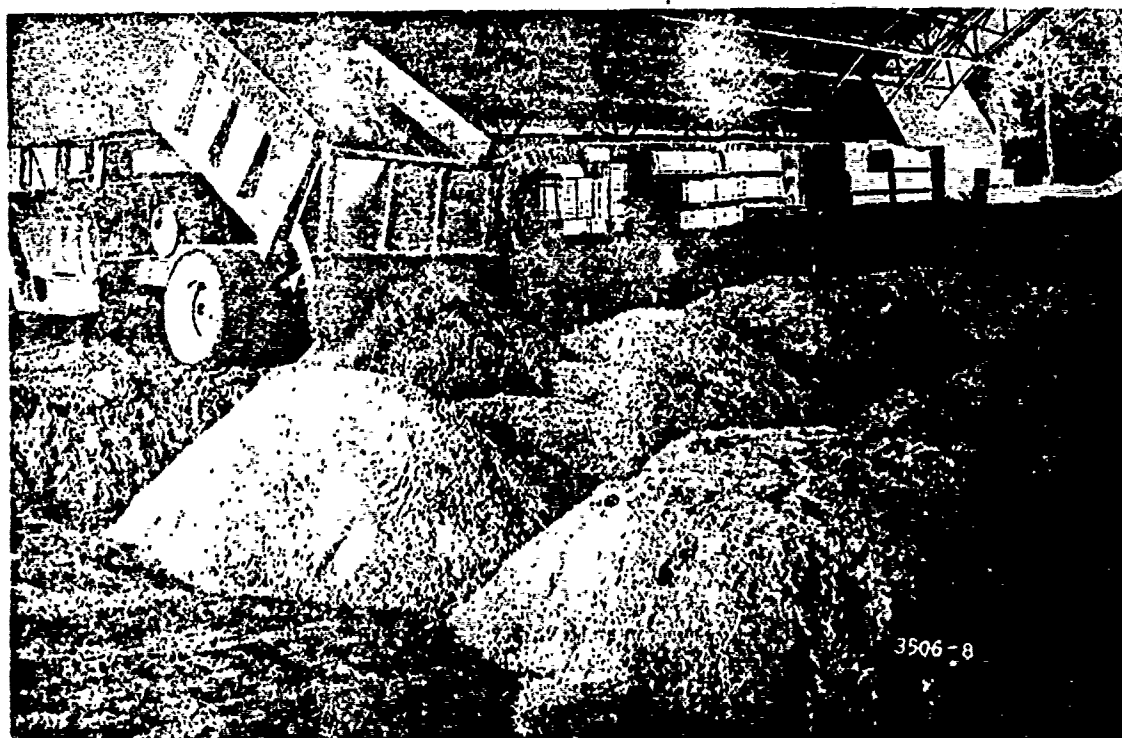
Fig. 4. End-dumping of sand in item 4

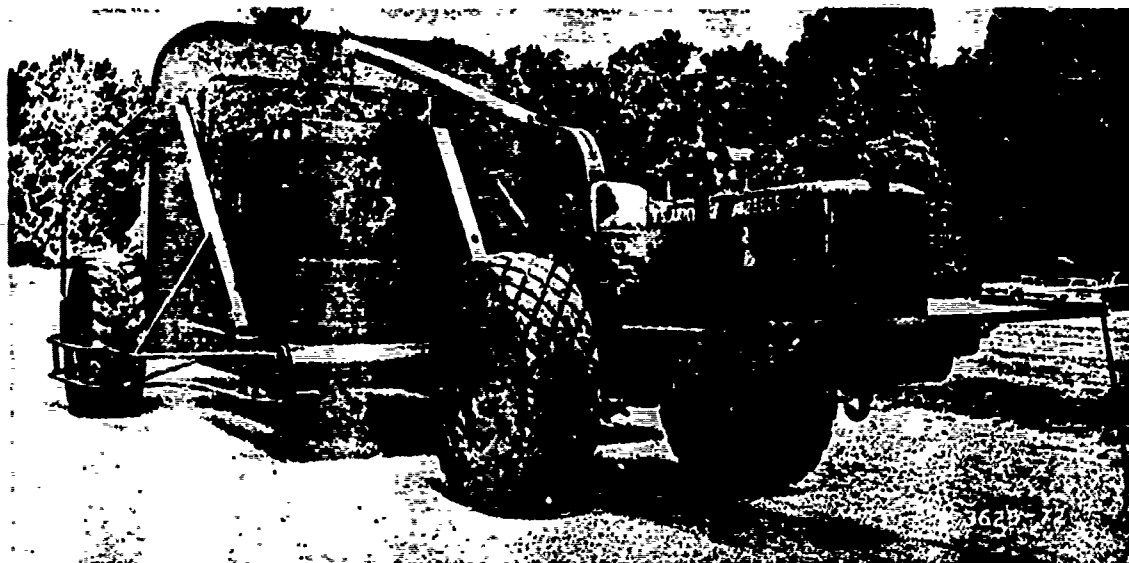
Fig. 7. Test load cart with 39,000-lb single-wheel load with tire inflated to 400 psi

contact area of 82 sq in. with a tire-print width of 7.3 in. The average contact pressure was about 330 psi. A large runway test cart (fig. 7) was used with the 30-7.7 tire for the 39,000-lb, single-wheel-load traffic. A close-up of the load wheel mounted under the load box is shown in fig. 8. The 39,000-lb load on this tire resulted in a contact area of 103 sq in. and an average contact pressure of 378 psi.

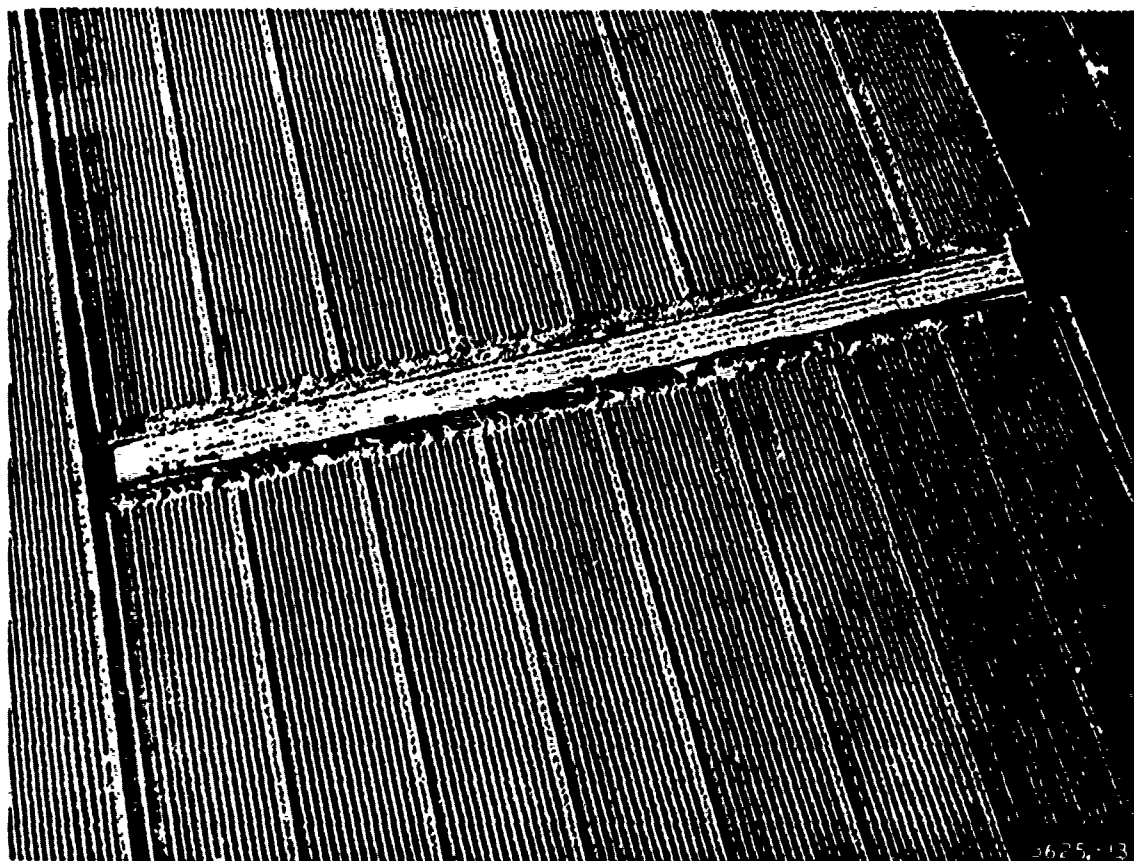
Fig. 10. Cracks at end joint and overlapping corner break in item 1 after 20 coverages of traffic

single-wheel load had no detrimental effects on types 1-a and 1-d mats, except for a minor crack at an end joint of a plank of type 1-d mat.

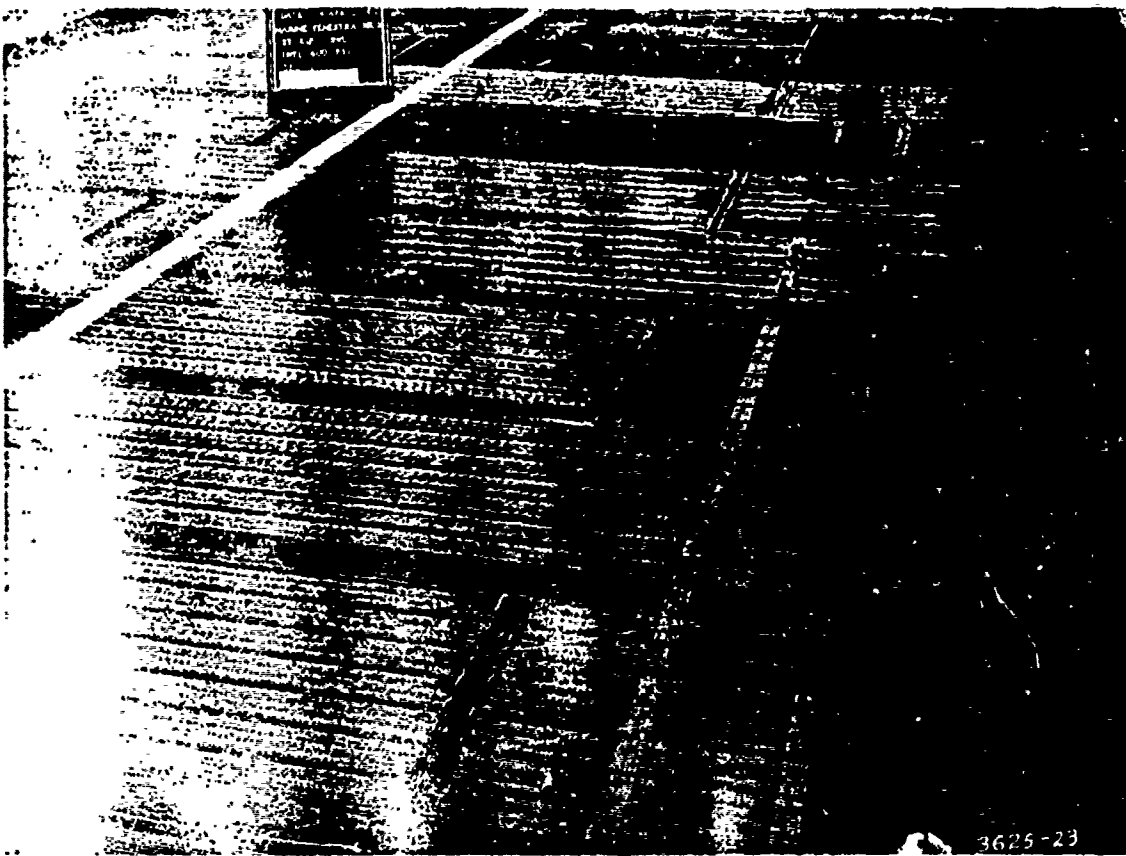
Fig. 13. Overlapping corner breaks in item 1 after 29 coverages of traffic with 27,000-lb single-wheel load

Number of overlapping corner breaks had developed, as shown in fig. 13. The loose projecting ends from these breaks were cut off to prevent tire damage, as shown in fig. 14. The breaks continued to progress as traffic

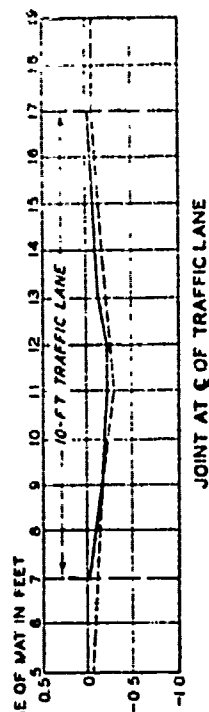
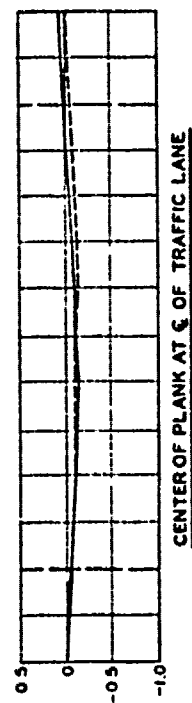
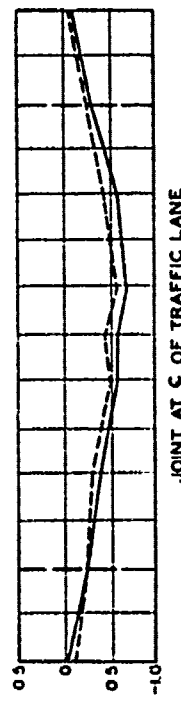
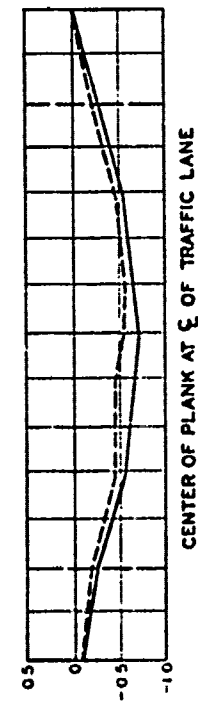
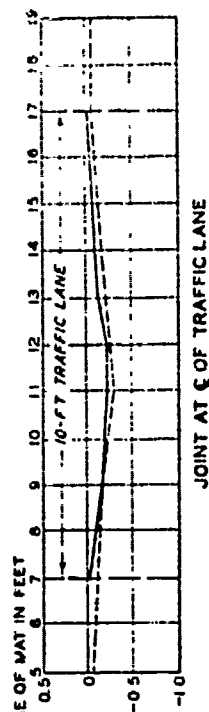
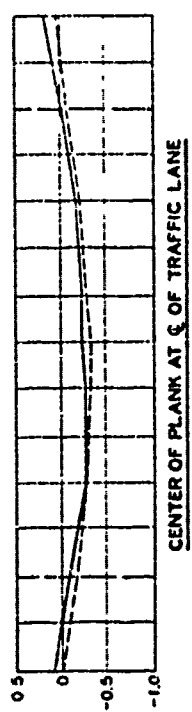
FENESTRA MARK III MAT  
PERMANENT DEFORMATION  
17,000-LB SINGLE-WHEEL LOAD

20. Permanent deformation. Level readings taken to show permanent deformation of the mat during traffic are shown in plate 4. As the mat was laid in a staggered pattern, every other run of mat consisted of two whole planks with an end joint located at the center of the traffic lane. The adjacent runs consisted of two half planks and a whole plank; one half plank was located on each side of the lane with the whole plank in the center so that the center of the whole plank was located at the center of the traffic lane. The data in plate 4 show average cross sections for both conditions for each item of the test lane. These data indicate that the deformation across the traffic lane is about the same regardless of where the end joint is located. The data also show that the permanent deformation in items 1 and 2 was very small with a maximum of about  $1/4$  in.,

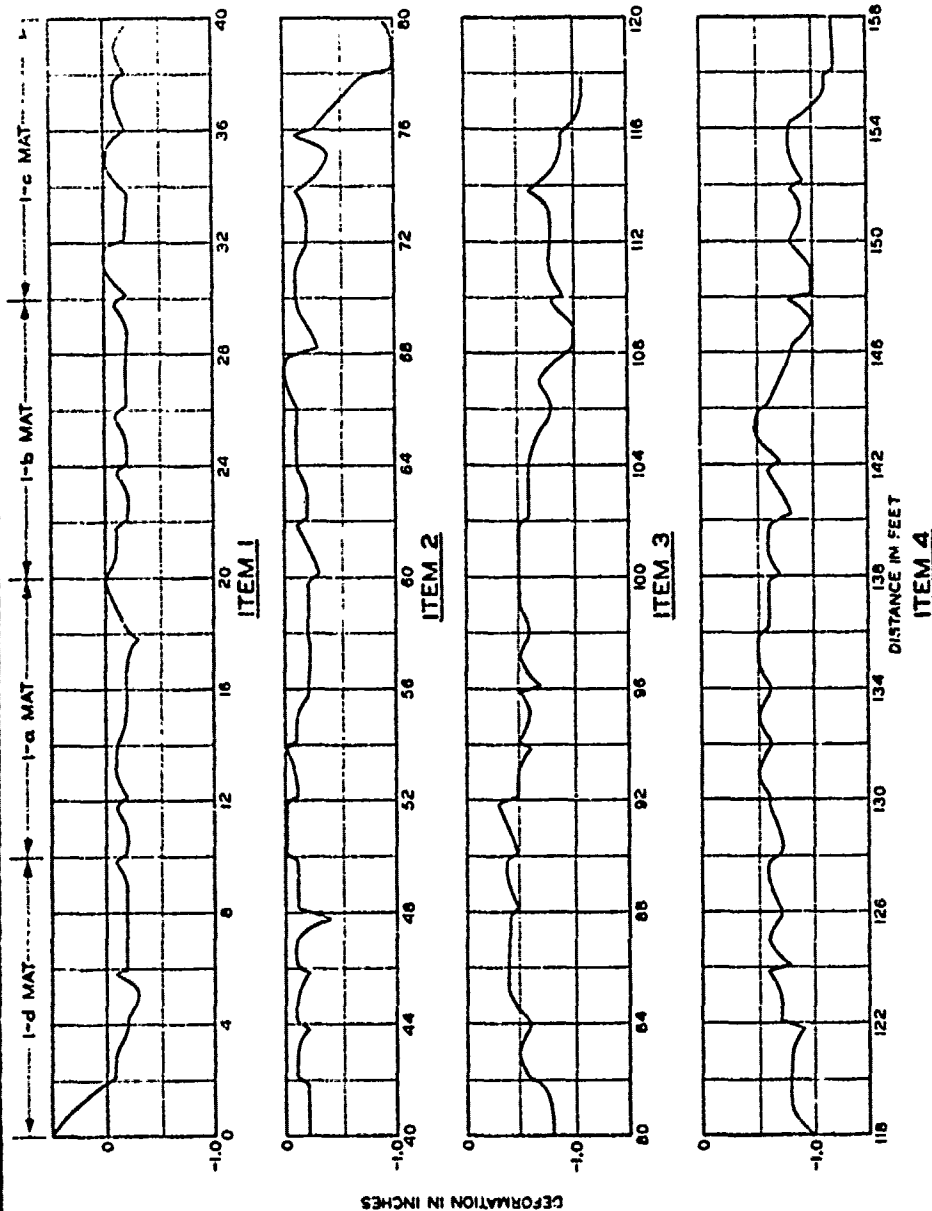
FENESTRA MARK III MAT  
 CENTER-LINE PROFILES  
 17,000-LB SINGLE-WHEEL LOAD  
 50 COVERAGES

21. Center-line profiles showing deformation of the mat in each test item down the center line of the test lane are shown in plate 5. These profiles show slight deviations in deformation within the various test items, but no consistent difference due to mat type. In general, the surface grade remained smooth throughout the 50 coverages of traffic, as can be noted in photograph 2.

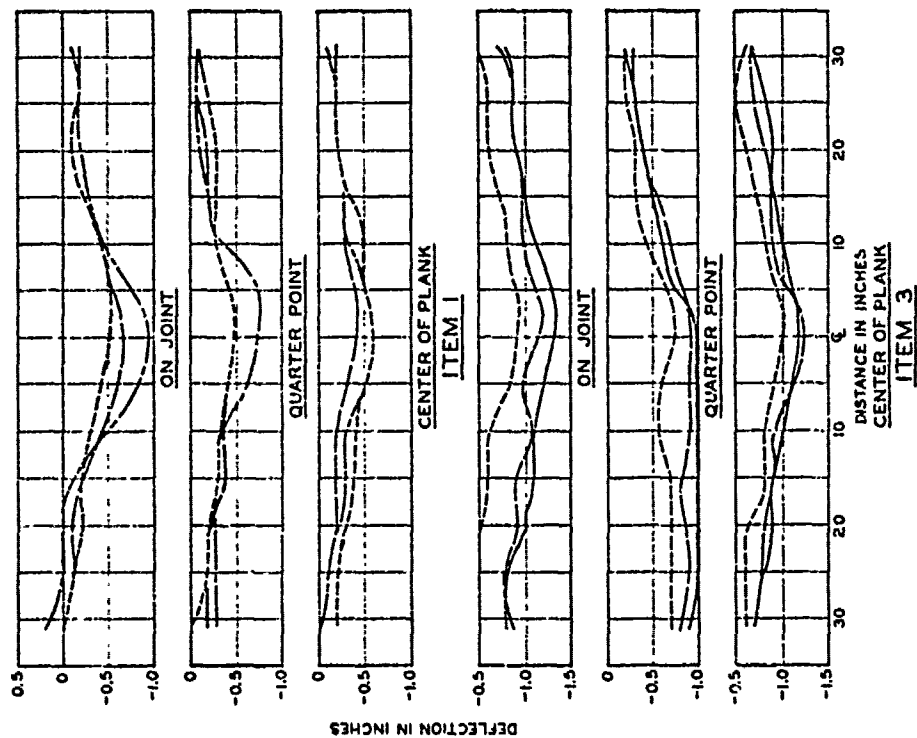
MAT DEFLECTIONS

29. Mat deflection. Plots presenting elastic deflection of the 1-a and 1-d mats under load for the various intervals of traffic are shown in plate 9. The mat deflection in item 4 was severe, exceeding 1.5 in. As discussed in paragraph 22, this severe deflection was due to the mat bridging the subgrade, as the mat did not conform to the subgrade after densification of the sand occurred under traffic. As can be noted in table 1, the density of the sand increased from about 91 lb per cu ft prior to traffic to about 106 to 111 lb per cu ft after traffic.

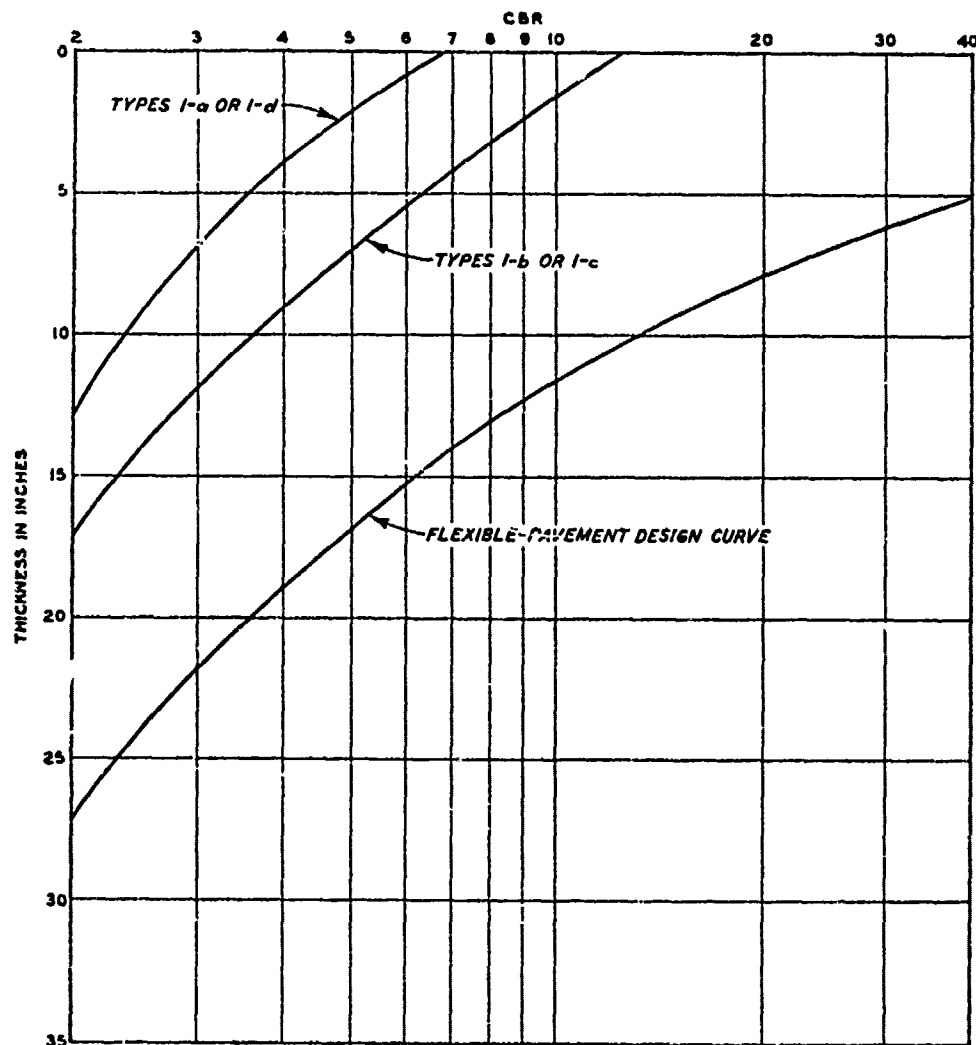
FENESTRA MARK III MAT  
 CBR DESIGN CURVES  
 27,000-LB SINGLE-WHEEL LOAD  
 400-PSI TIRE PRESSURE  
 188 COVERAGES

45. The data obtained from the loose rock and sand test items were not used in developing the design curves shown in plate 11. However, the data indicated that a loose sand or rock subgrade with an initial CBR of 4 or better, surfaced with type 1-a or 1-d mat, would perform satisfactorily for 188 coverages of the 27,000-lb wheel load provided that the severe mat deflections caused by the mat bridging the subgrade were not detrimental to aircraft performance. A slightly higher initial subgrade strength would be required for type 1-b or 1-c mat.

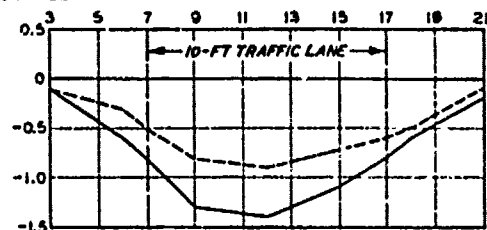
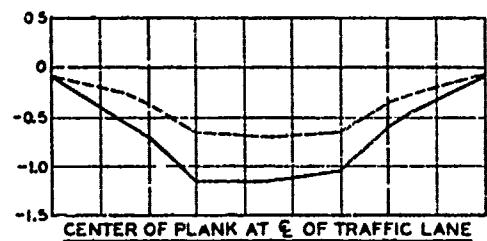
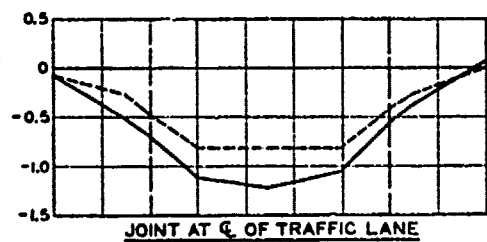
BUTLER AMI MAT  
PERMANENT DEFORMATION  
27,000-LB SINGLE-WHEEL LOAD

65. Permanent deformation. Level readings taken to show permanent deformation of the mat during traffic are shown in plate 13 for all test items. From these data it can be noted that little settlement occurred in any of the clay subgrades, items 1 through 3. However, considerable deformation occurred in items 4 and 5, rock and sand subgrade items, respectively. This deformation was due to densification of the rock and sand under traffic, as was the case for the Fenestra mat discussed previously.

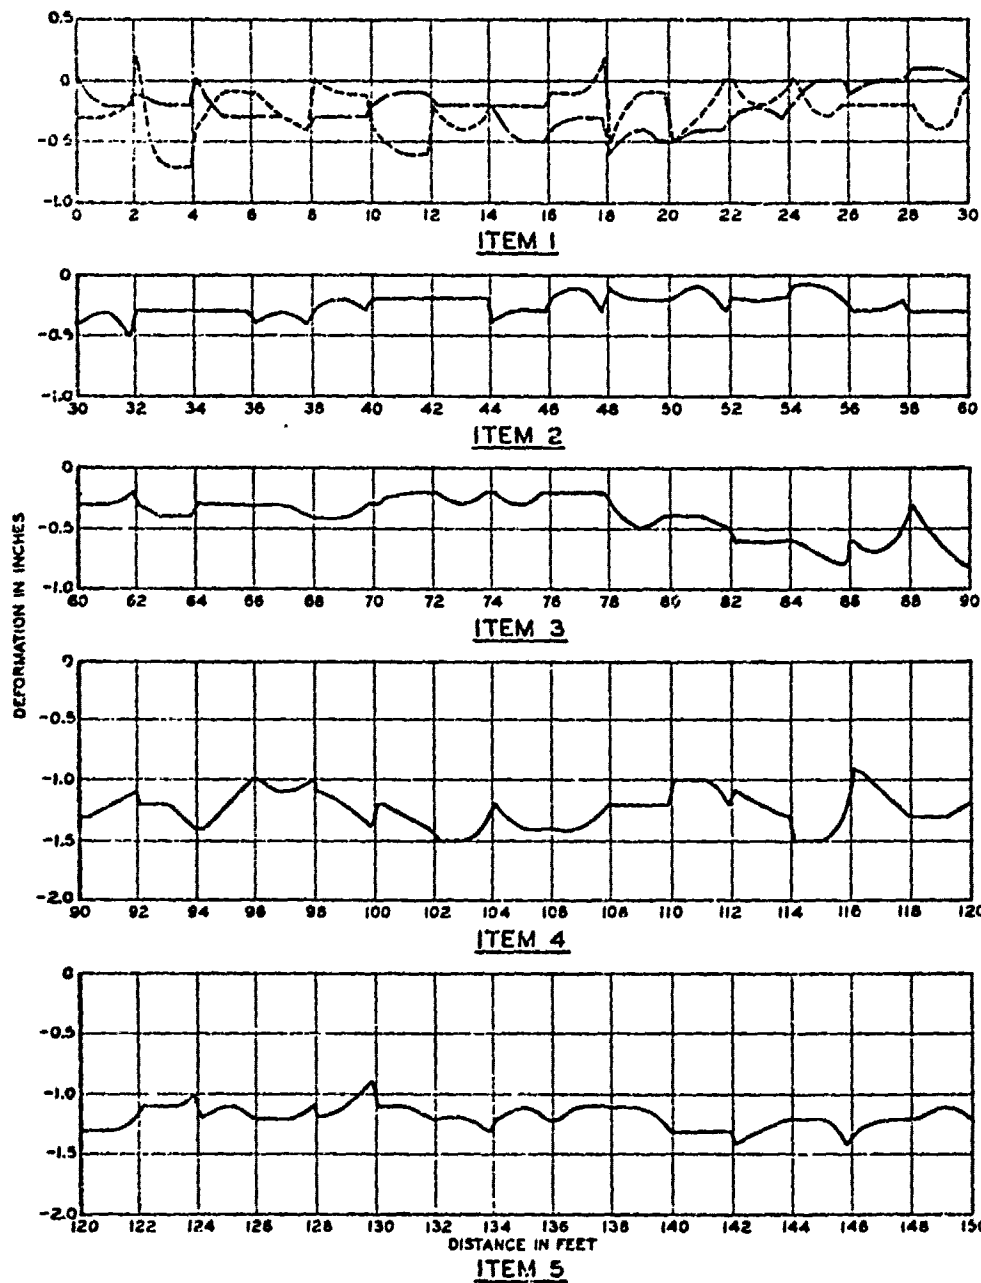
BUTLER AMI MAT  
 CENTER-LINE PROFILES  
 27,000-LB SINGLE-WHEEL LOAD

66. Profiles showing the deformation of the mat along the center line of the test lane are shown in plate 14. These data show considerable deviation in the deformation of adjacent mat planks in item 1 at the end of 36 and 138 coverages, respectively. This is due primarily to breaks in the end joints. This condition would result in a rough riding surface. The mat surface remained fairly smooth in items 2, 3, 4, and 5 throughout the period of traffic, even though considerable deformation occurred in items 4 and 5.

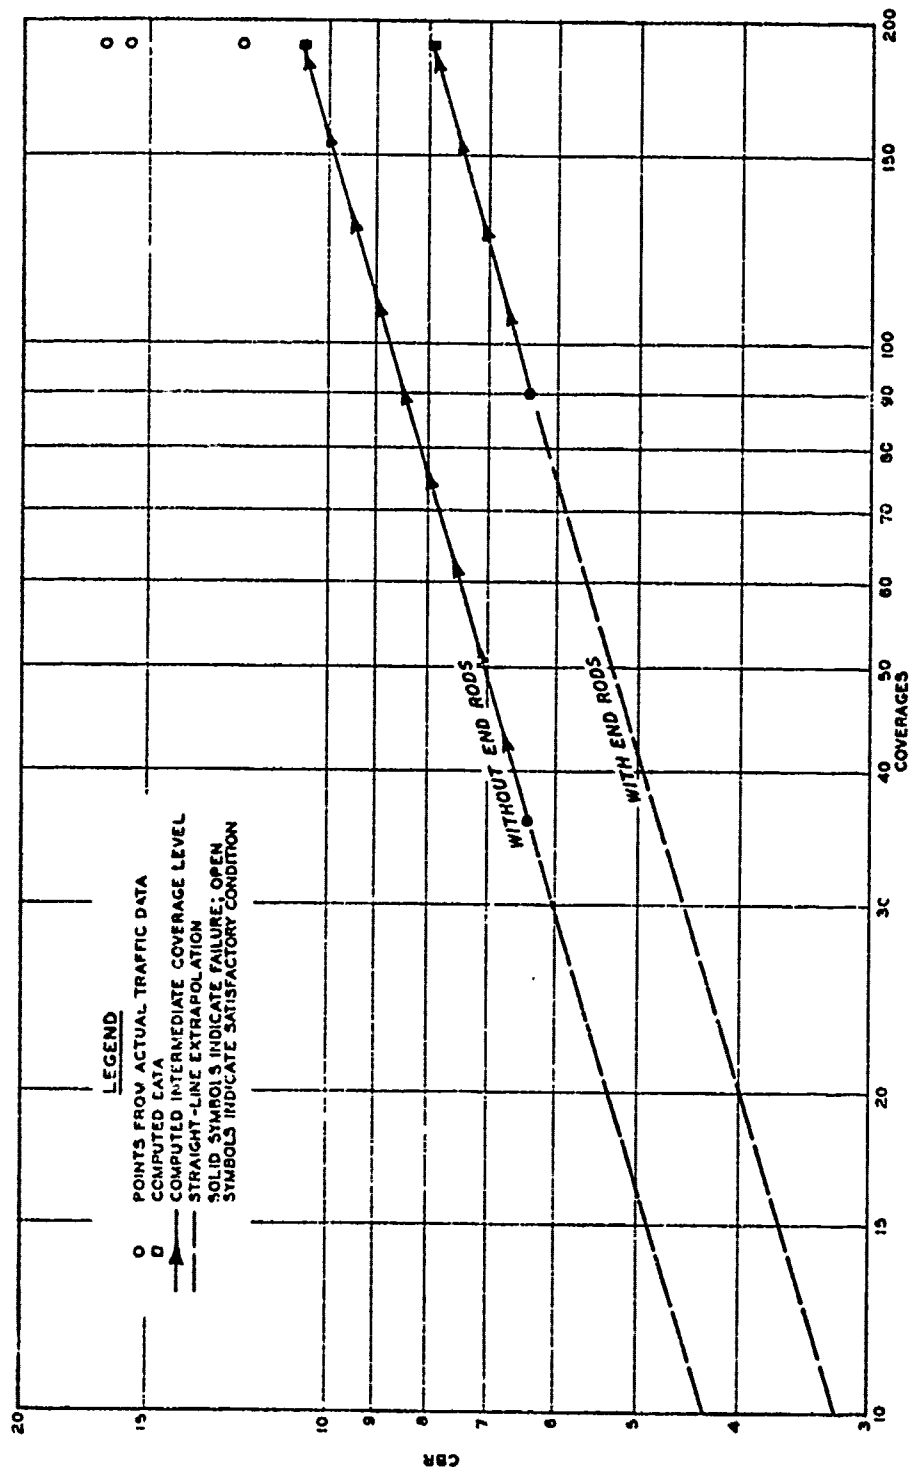
BUTLEN AMI MAT  
CBR VS COVERAGES  
27,000-LB SINGLE-WHEEL LOAD  
400-PSI TIRE PRESSURE

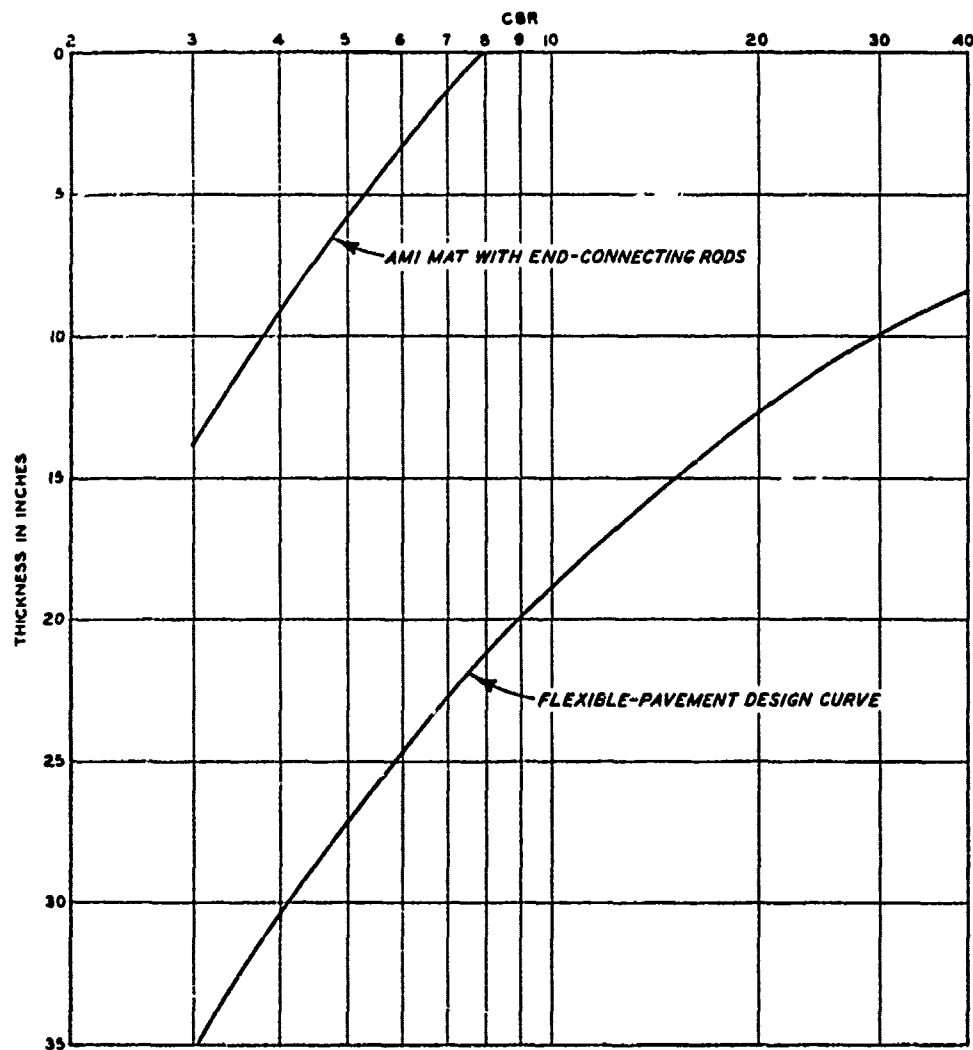
BUTLER AMI MAT  
CBR DESIGN CURVES  
39,000-LB SINGLE-WHEEL LOAD  
400-PSI TIRE PRESSURE  
1600 PASSES
